Cost Analysis of Conventional Speed Breakers with Steel Grid - A Case Study

Abstract – Finding a solution to the problem faced by mankind is a but natural tendency but it should be cost effective as well as serve the intended purpose with a little of maintenance requirement. Such a problem was faced by residents of sector-10, Panchkula where the residents faced a problem due to storm water. As storm water will move everywhere, where it find its way. The storm water enters in the sector from the dividing roads of sector 10-15, 10-9, 10-5 and 10-11. Out of these dividing roads the condition of dividing at sector 10-15 and 10-9 was worst. Water was causing a lot of problem to residents and standing as well as moving vehicles. In order to curb this tendency of flowing water, which creates a lot of problem to residents living nearby residents has created huge humps at dividing roads of sector which instead of solving the problem has created various other problems.

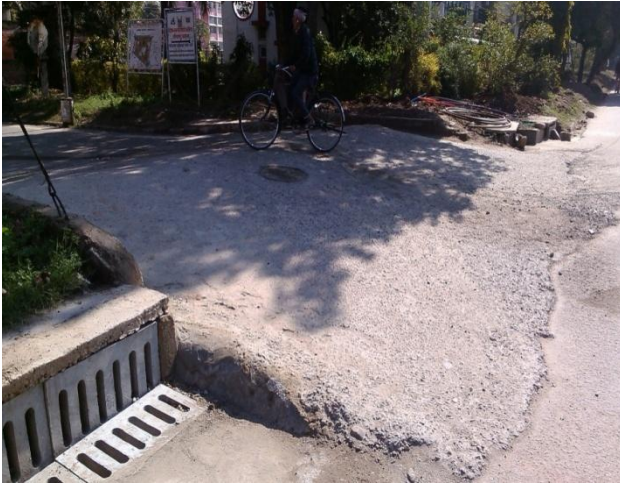
Fig.2.

2.1 A view of the hump at the dividing road of sectors 10-15, Panchkula

- It can be inferred from the figure and data that the hump neither fulfils its specifications with respect to its height, slope, length nor does it properly indicate its presence through warning sign or paint. Apart from this, it starts at just a distance of 4.26m from major road against the minimum specified distance of 10m by IRC-99-1988.
- It produces a lot of noise especially when heavily loaded vehicle pass over it, thereby causing a lot of inconvenience to nearby residents.
- Its height at centre is 0.53m as against 0.10m as specified by IRC which may lead to excessive wear and tear of passing vehicles. It may even have adverse impact on the axle of sedans.

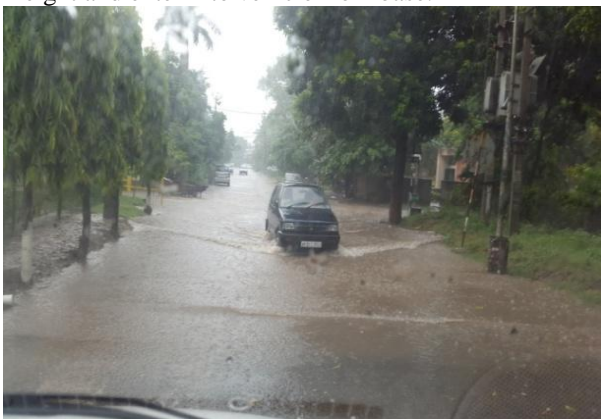
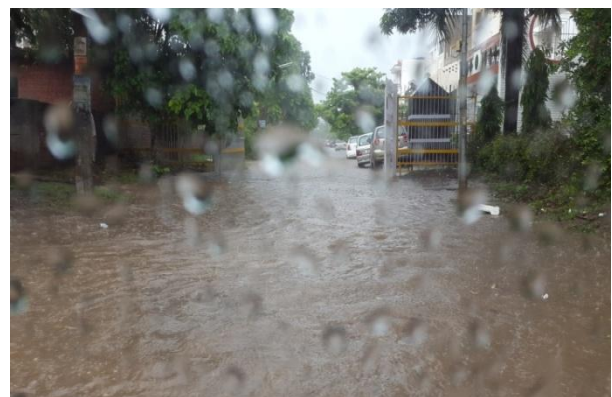
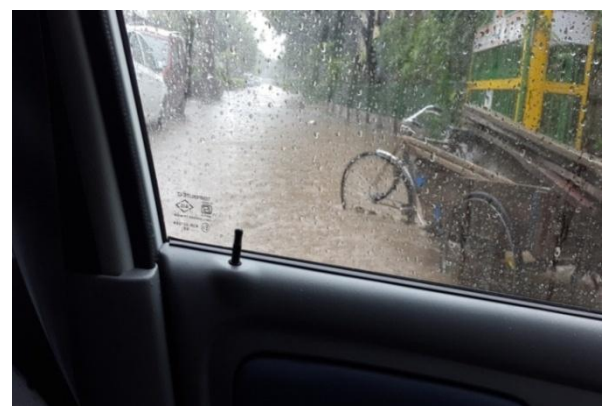
- As per the information gathered from personal interaction with residents these humps were built to stop the ingress of storm water in the sector during rainy season. But from the photographs taken during rainy season, it does not show any type of relief from storm water. The lanes are still running full of water and the water is sufficient enough to submerge the $\frac{3}{4}$ of tyre height and enter into vehicle from base.

- In the subsequent photographs (Fig.3, 4, 5) taken during rainy season it can be observed that the lane is fully flooded with water. The vehicular traffic and pedestrians face a lot of problems in crossing the area.

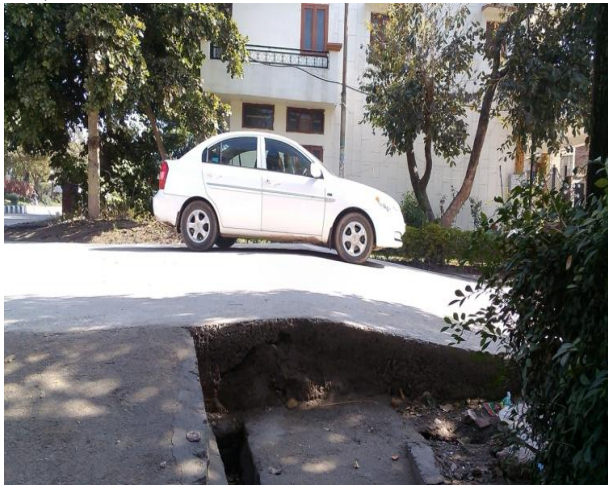
Fig.6.

2.2 A view of the hump at the dividing road of sectors 10-9, Panchkula

- It can be inferred from the figure and data that as the height of hump is 0.33m against 0.10m as specified by IRC. The general ground clearance of four vehicles especially sedans is 0.168m. When a sedan will pass over this hump, it can have adverse impact on the axle of sedans.
- Length of hump is 13.21m against 5m as specified by IRC.
- The slope is 1:15.5 against 1:20 which will make the riding quality poor.
- It starts at a distance of 5.11m from the edge of major road against a minimum of 10m as specified by IRC. Thus a vehicle entering to major road or to minor road will not be able to control the vehicle and may lead to a fatality.

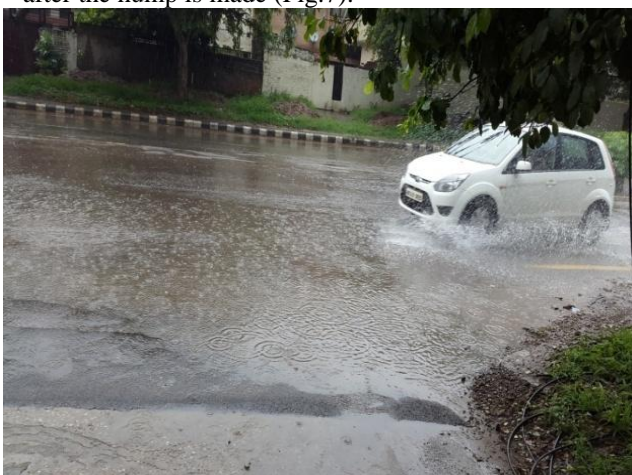
Fig.7.

- No warning sign has been put on road and even the hump is not painted with alternate black and white strips.
- The problem of water accumulation still stands even after the hump is made (Fig.7).

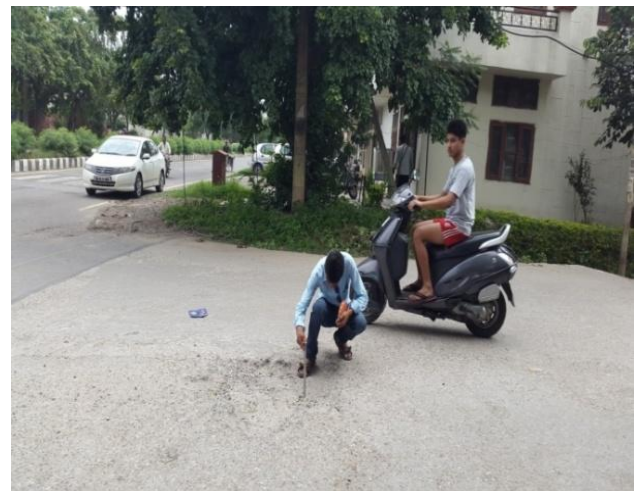
Fig.8.

- The hump is not provided on the kerb area. Also due to this the water enters into the lawn of nearby resident area also. (Fig.9.)
- The top of hump is having a pit of 6 inch depth sufficient enough to make a vehicle loose its balance especially if it is a two wheeler. (Fig.8.)

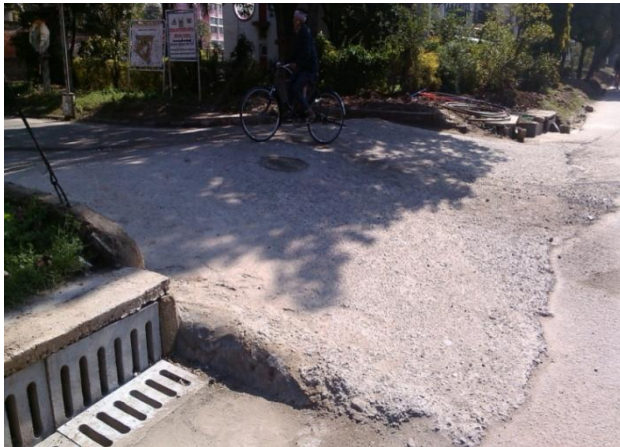
Fig.10.

The construction cost of a concrete hump made at dividing of sector 10-15, Panchkula was worked out on the basis of certain assumptions and is given in following paragraphs. The cost may vary depending on the values assumed in calculations. (Fig.10)

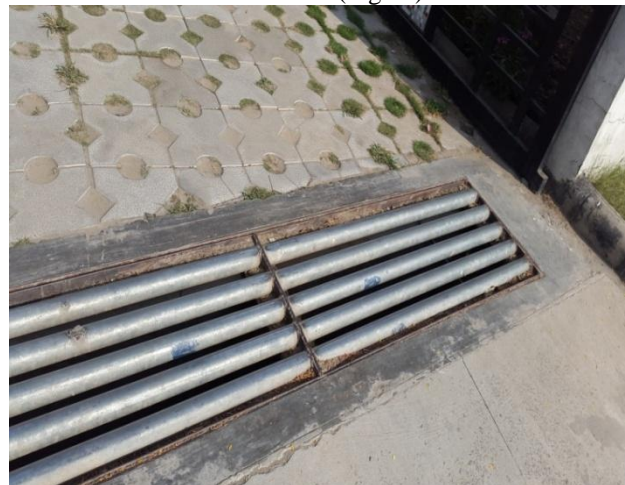
An alternative to solve the problem of draining water was with making a steel pipe grid as is shown in photograph. It not only ensures drainage of all the storm water but is cost effective also. (Fig.11)

Fig.11. A steel pipe arrangement made at sector-17, Panchkula.

It was proposed that instead of providing the concrete humps if in 0.5m wide area steel pipes would have been laid throughout the carriage way, it would have solved the purpose well in a better way.
